## INCIDENT INVESTIGATION REPORT

Short title: Potential Asbestos Exposure

Exact location of incident: Reservoir, Rabbit Proof Fence Road

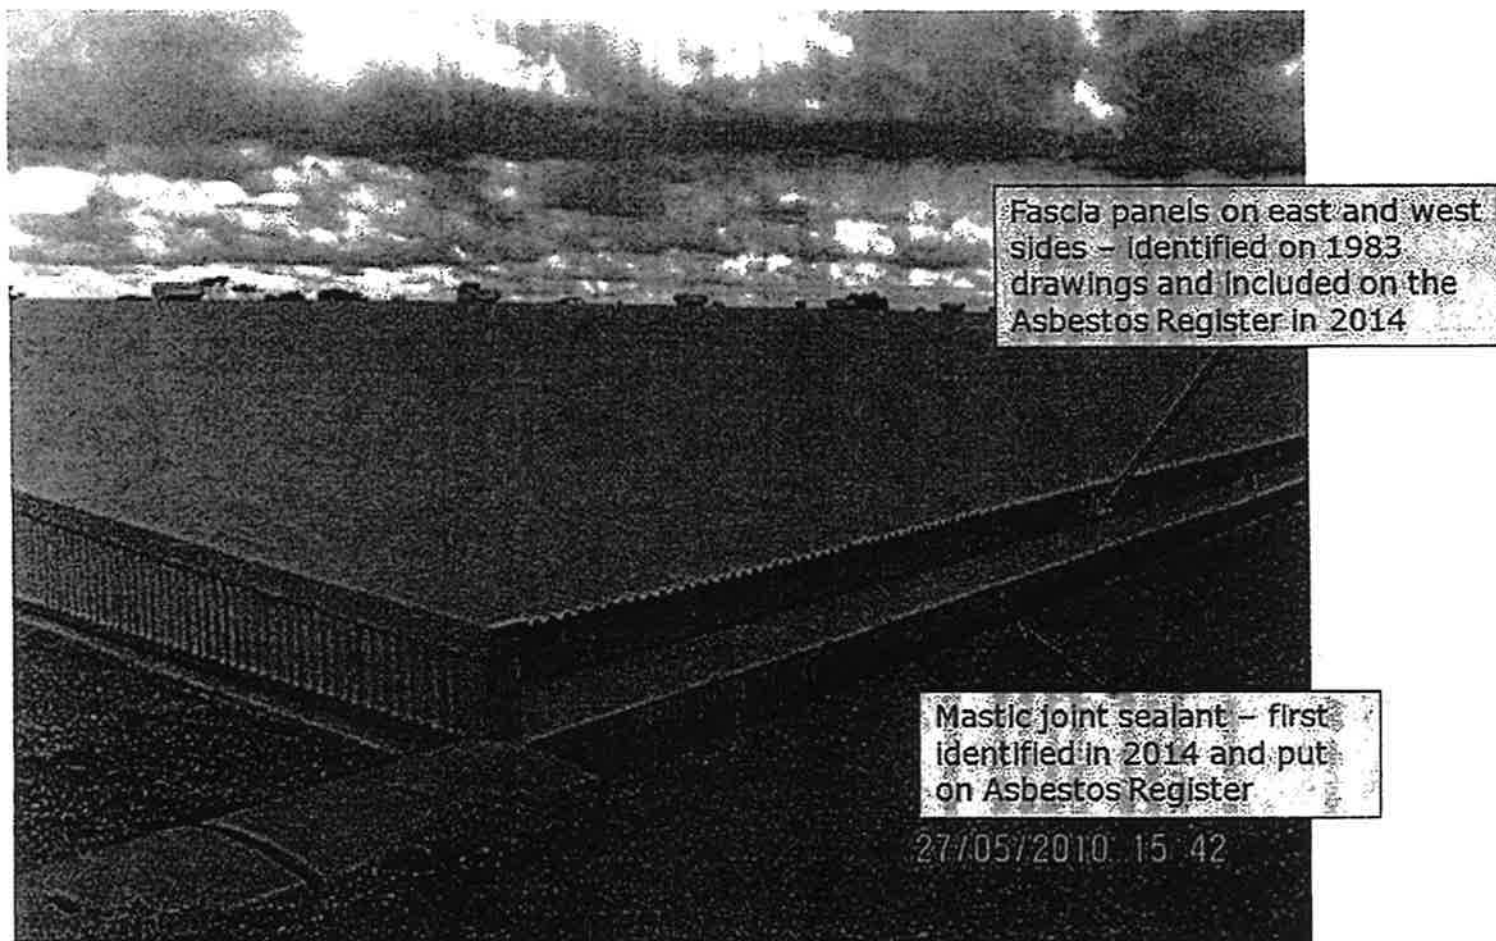
Figure 2 – I      roof 2010 (prior to refurbishment)

- Stage 1    Removal of fascia panels – these were unscrewed and manually removed.  
                 Grinding of the mastic (joint sealant) that was present in the concrete gutters.
- Stage 2    Grinding of the mastic used as a sealant between the concrete sections on the flooring to achieve a level finish.

Figure 2 shows the reservoir in May 2010. The areas that are known to contain asbestos are highlighted.
