## ICAM Report

### Missing and Loose Wheel Nuts on Cat 785D Rear Dump Truck (RD1)

Near Miss – Missing and loose wheel nuts on Position 3 wheel of Cat 785D Rear Dump Truck (RD1).

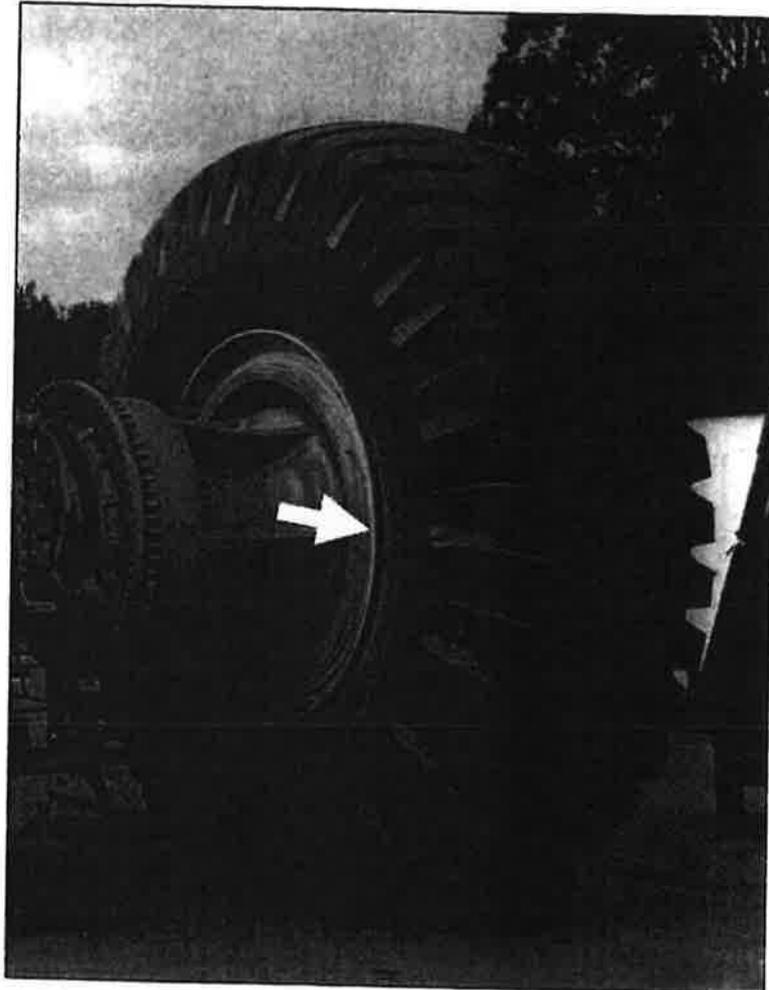
Figure 3. Disassembled dump truck with Position 3 wheel only in place. Adaptor ring had missing and loose wheel nuts
