# INCIDENT INVESTIGATION REPORT

## *Dozer 320 Rollover Ramp 25 North*

**Xxxx Mine**

***Occurrence Date: 26 April 2011***

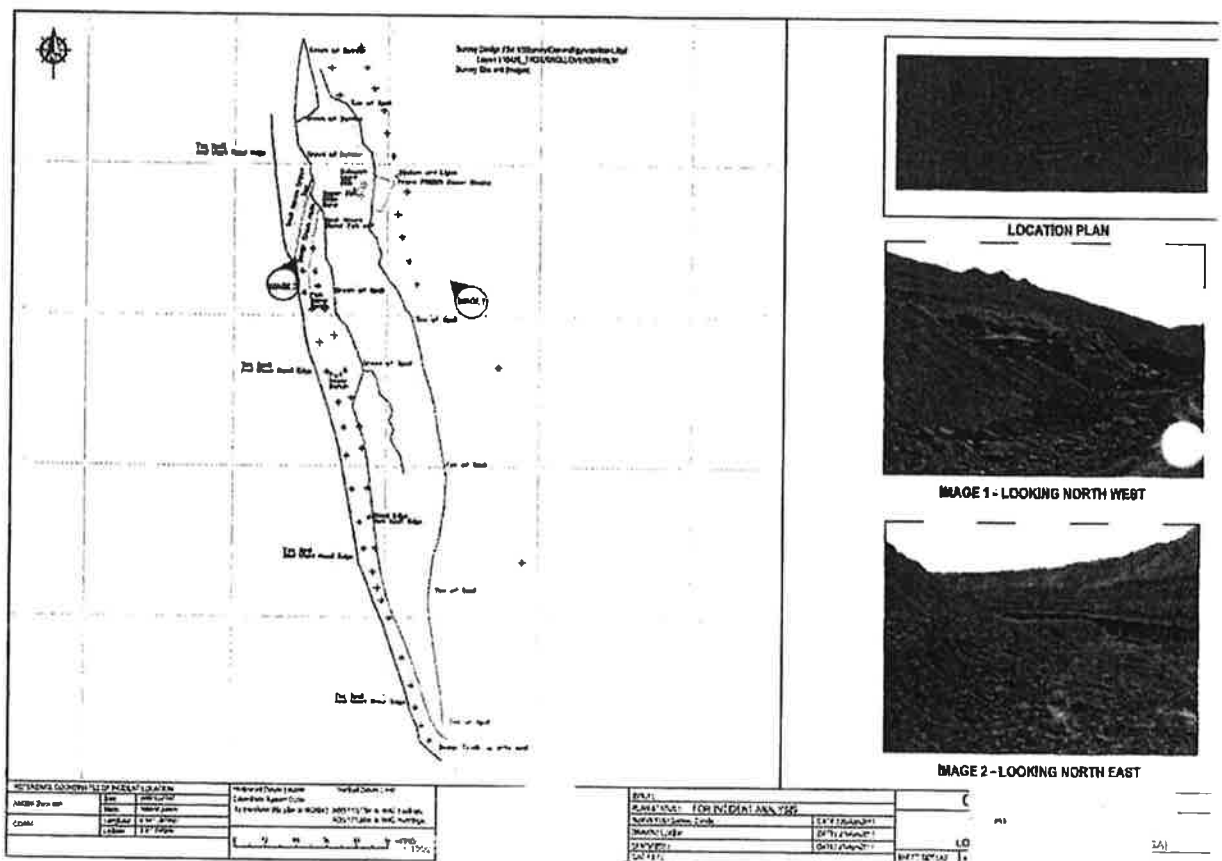
Figure 1: Survey of incident scene

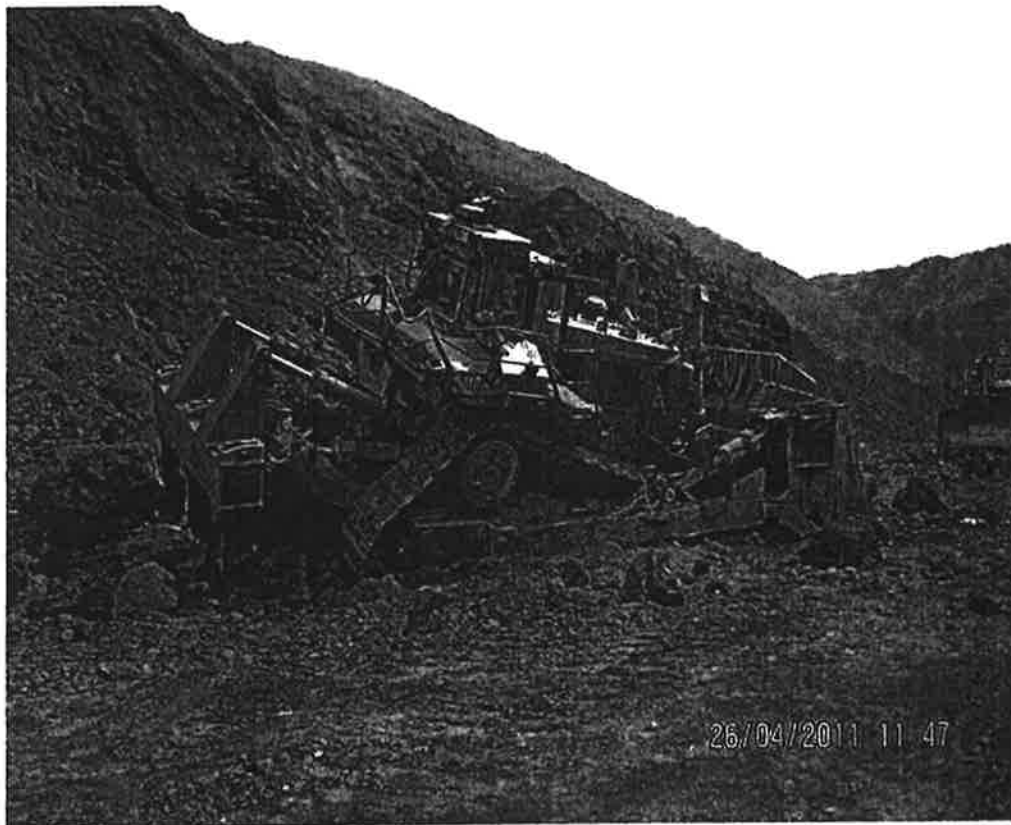
**Damage to Equipment:** Damage to exhaust stacks, handrails and rooftop numbering. Minimal damage to structural integrity of machine.

Figure 2: Final position of dozer

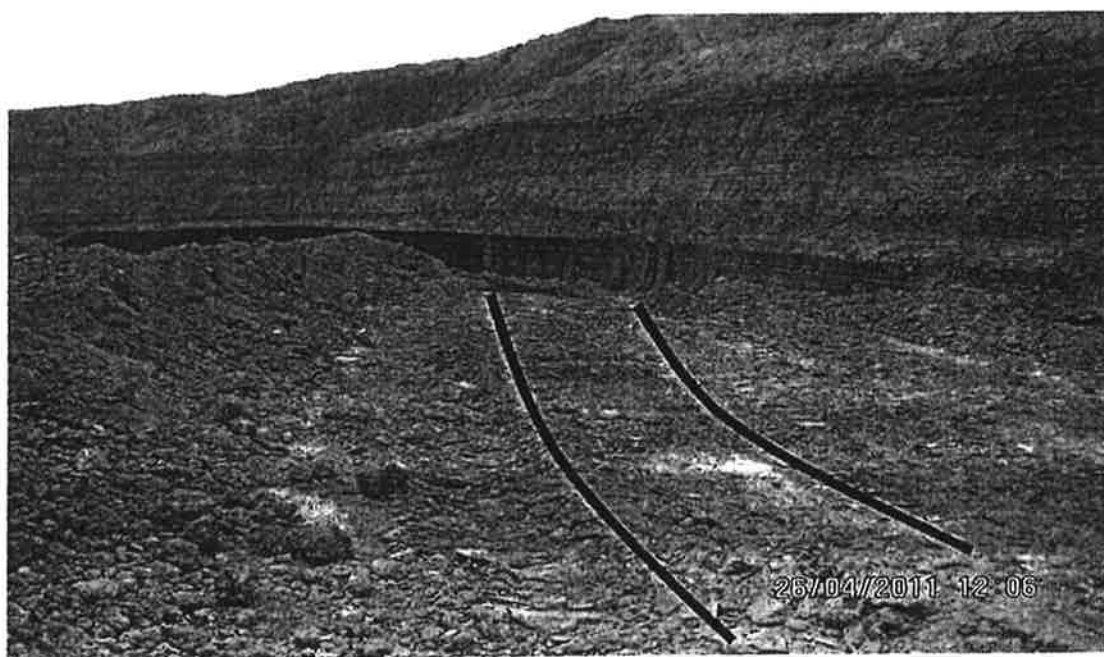
The coal edge has either suffered damaged from blasting which had previously occurred or there was a fault present in the coal. When the dozer moved over the fault or blasting damage it caused the damaged or section of the fault to fail under the dozer and caused the material to subside which inturn caused the right hand track to fall away. There was insufficient material under the right hand side of the dozer to support the dozer which caused it to roll.

**Figure 3:** *Approximate path taken by dozer on top of bench*
