## ICAM INVESTIGATION REPORT

205RL Dump slumped while rear dump truck  
was tipping

Location:	205RL Dume West
Time:	04:28am
Date :

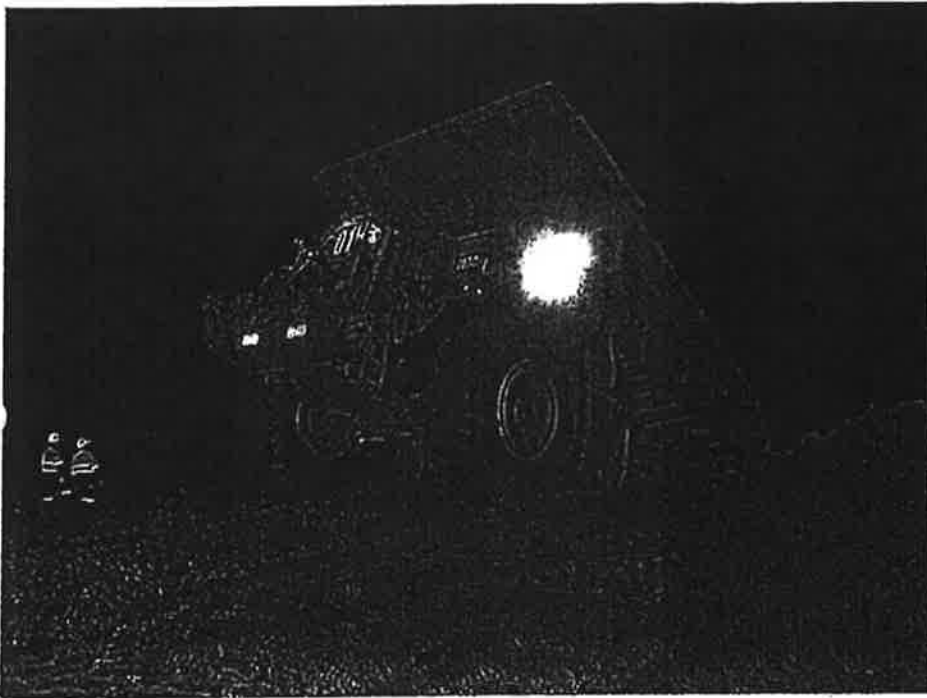
Towards the end of shift at approximately 04:20am, Dump truck 01 entered the 205RL dump and proceeded to dump at the tip head. As dump truck 01 was lowering the rear tray after tipping the payload, the dump began to slump approximately 4 meters from the tip face and caused the rear of the dump truck to sink down with the slumping and rest on the undercarriage.

*Picture 1 - Truck 01 final resting position on 205RL Dump*

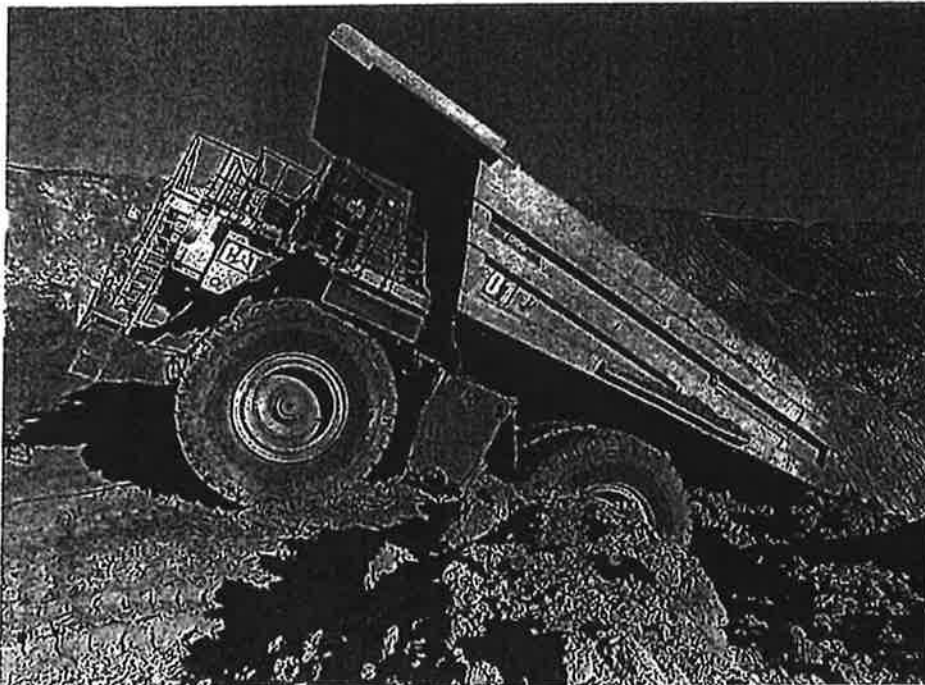
*Picture 2 - Day light and recovery phase of Truck 01*

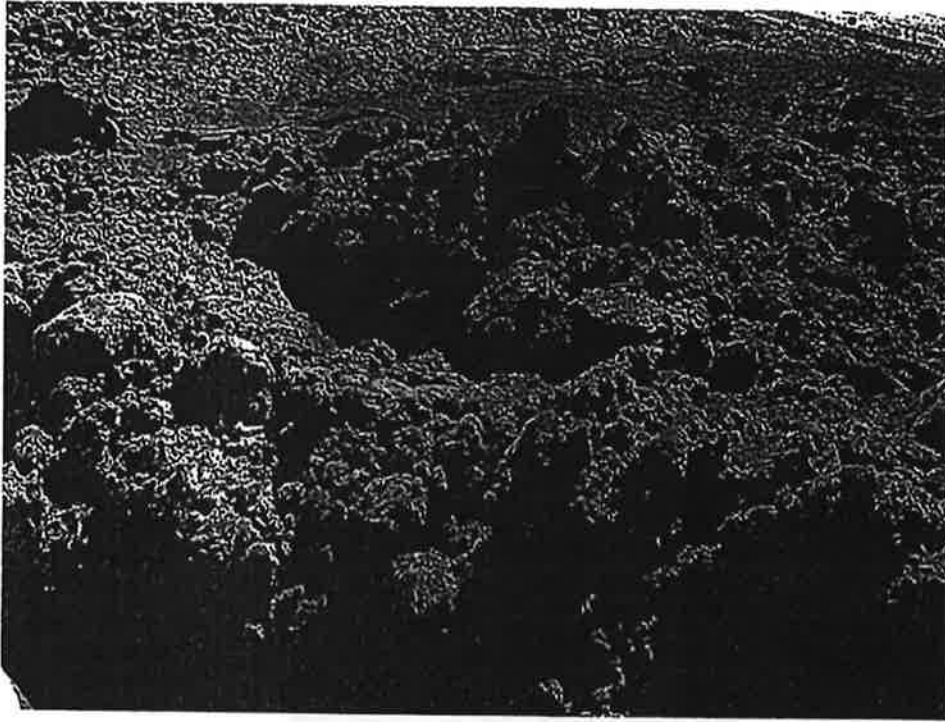
- Following the incident, the project geologist examined the dump material and determined that the material used for the 205 RL dump was an medium to fine grained alluvium sand with a clay matrix. Small to medium clasts of igneous material were also visible. The material was noticeably water logged after recent rain events.

Picture 3 - water logged alluvium sand with a clay matrix

The investigation team has determined that the basic cause of the incident was incompetent material being used to construct a waste dump 25 metres in height.

TE 7 - Materials suitability - Water logged material was too wet and unsuitable for the dump height.
